# Manhole Inspection Summary

Manhole # S23EE1003MH

Insp Date: **2/22/07 2:23 PM**

**Location** Address: **1425 41ST ST**

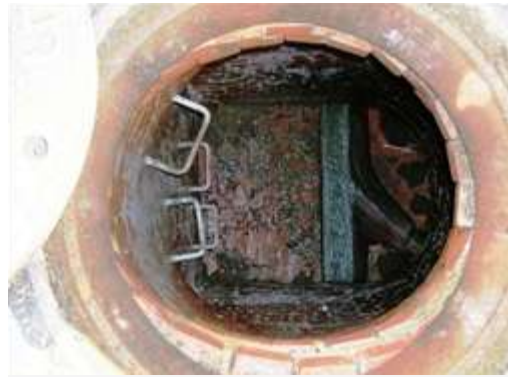
Top View

☒ **Debris** (not Condition related)

Bench debris.

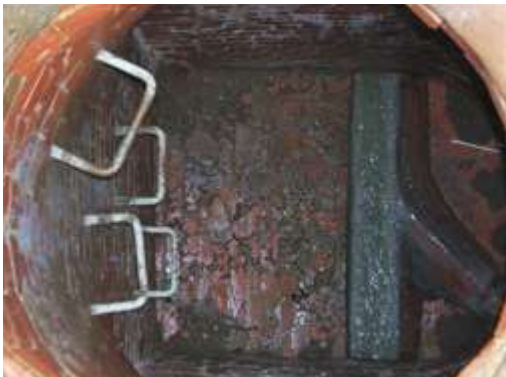
Top View

Bench debris

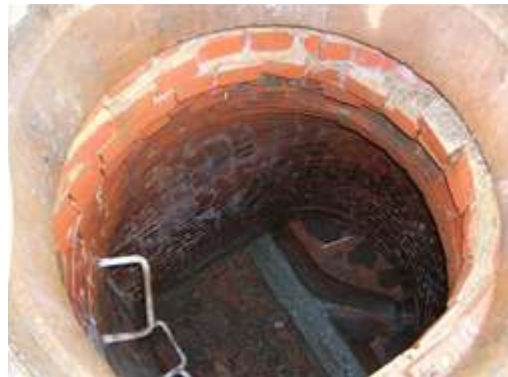
Defect

Offset: **1** (in.)

☒ **Leaks**

Condition: ☐ Sound ☐ Cracked ☐ Root Intrusion ☒ **Loose Brick** ☒ **Deteriorated**

Infiltration: ☐ None ☒ **Joint** ☐ Cracks ☒ **Mortar** ☐ Roots ☐ Wall

Infiltration: ☐ None ☐ Joint ☐ Cracks ☒ **Mortar** ☐ Roots ☒ **Wall**

Frame leaks. Frame offset. Adjustment deterioration, loose brick, and infiltration. Corbel and Barrel infiltration - other side.

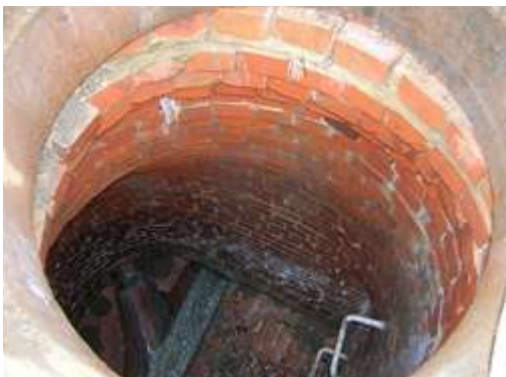
Defect

Frame leaks. Frame offset. Adjustment deterioration, loose brick, and infiltration. Corbel and Barrel infiltration.

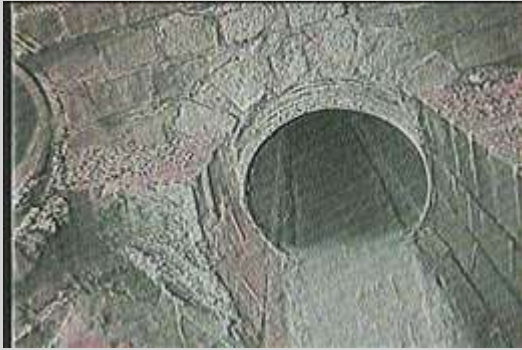
Pipe In @ 6 O'Clock

Condition: ☐ Sound ☐ Cracked ☐ Root Intrusion ☒ **Deteriorated** ☐ Leaks ☐ Debris

Channel deterioration.

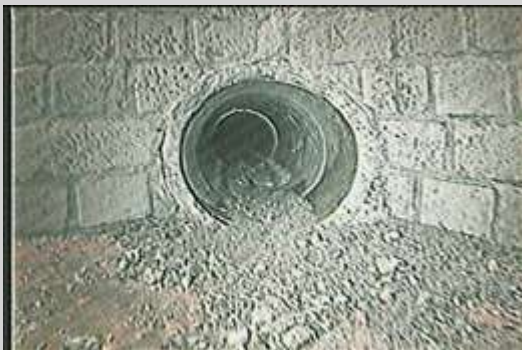
Pipe In @ 10 O'Clock

Deposits: ☐ None ☒ **Mud** ☐ Sludge ☒ **Debris** ☐ Grease

Silt Depth: **0.5** (in.) Deposits Extent: **Light**
